# Manhole Inspection Summary

Manhole # S11CC2012MH

**Location** Address: **2240 CREST RD**

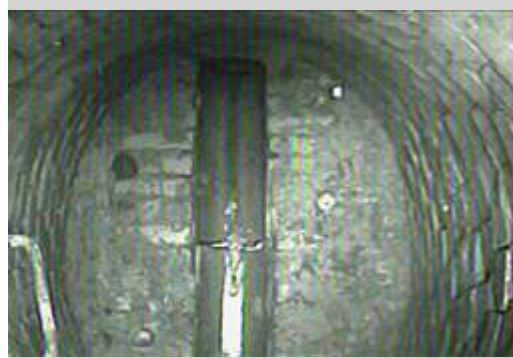
Top View

Barrel deterioration. Bench debris.

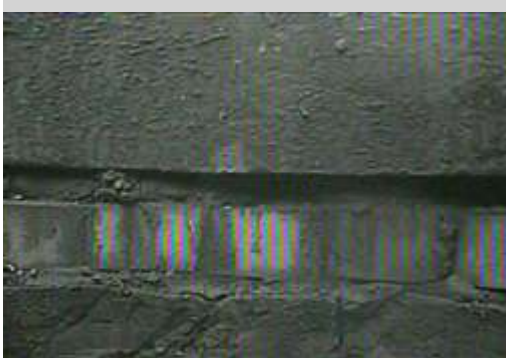
Defect

Frame leaks. Adjustment infiltration.

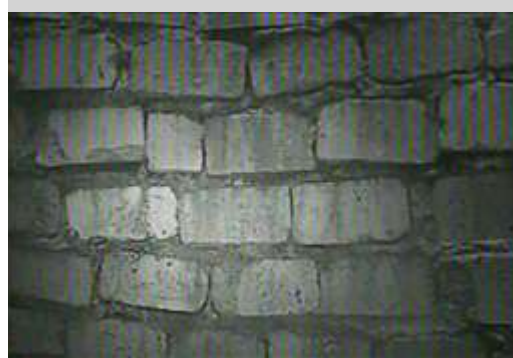
Defect

Barrel infiltration.

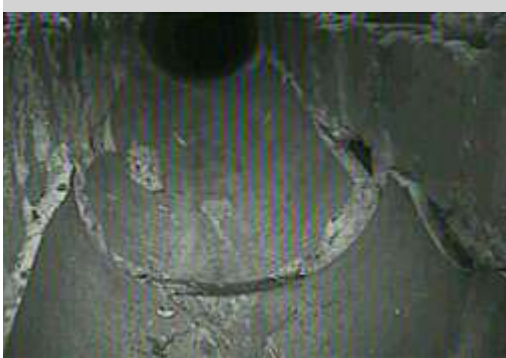
Defect

Channel deterioration.

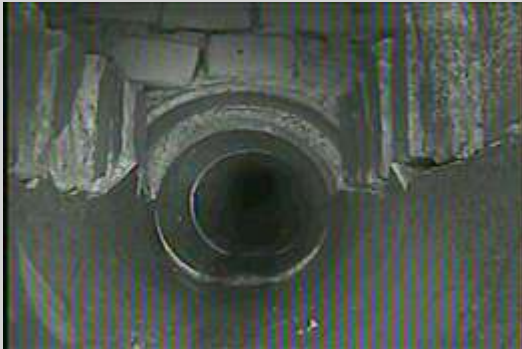
### 8 in. Circular Gravity Sewer Pipe Out @ 12 O'Clock

Infiltration: **None** Pipe Seal Cond: **Unknown**

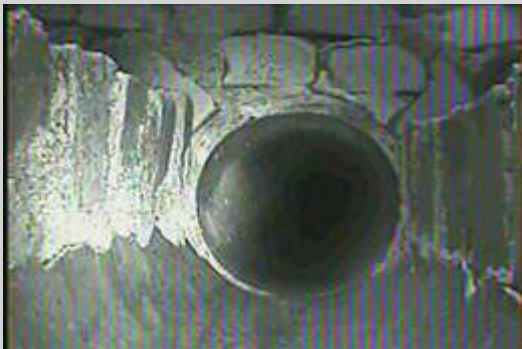
### 8 in. Circular Gravity Sewer Pipe In @ 6 O'Clock

Infiltration: **Evidence** Pipe Seal Cond: **Unknown**
